# Home Energy Assessment Report

Assessor Name: Scott Katznelson

## **ASSESSMENT SUMMARY**

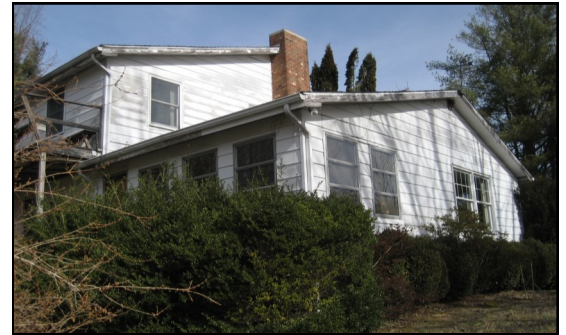
Louvered windows should definitely be replaced with double-glazed, low E windows. The energy model of the home also recommends changing out all of the currently existing single paned windows.

- 3.** While generally window replacement is not necessarily cost-effective, in this home it is recommended for all windows that are not already double-paned. The payback for this is estimated to be about 12—14 years. For the louvered windows, this payback period is more like 6 years.

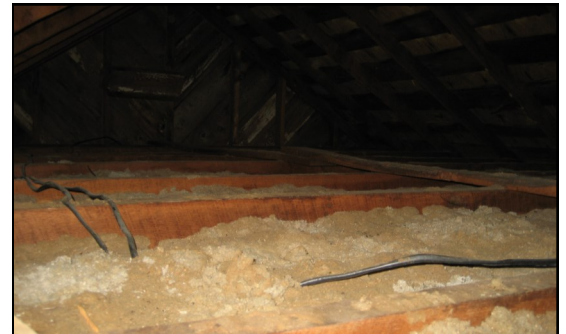
Insulation levels are inadequate in the attics and should be improved with blown cellulose or fiberglass up to a minimum of 12”.

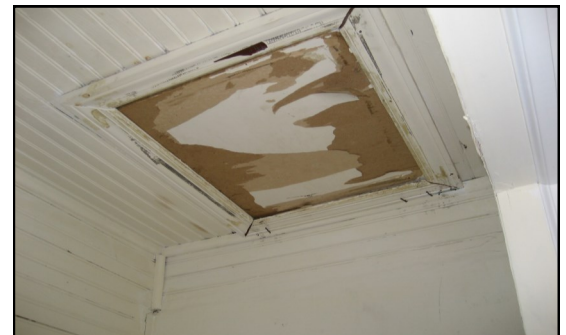
The Attic hatch on the second floor, and the one in the southern addition should both be air sealed and insulated up to R38. This can be done either with fiberglass batt or rigid insulating sheathing.

- 9.** The attic hatch should be air sealed and insulated. It will likely be necessary to build a new frame for the hatch in order to make a good seal possible.
- 10.** The drywall covering the old attic access (or window) between the garage and the master bedroom, should be properly insulated and sealed.
- 11.** Moisture issues in the home may be alleviated by the use of a vapor barrier throughout the crawlspace. However access is very difficult.

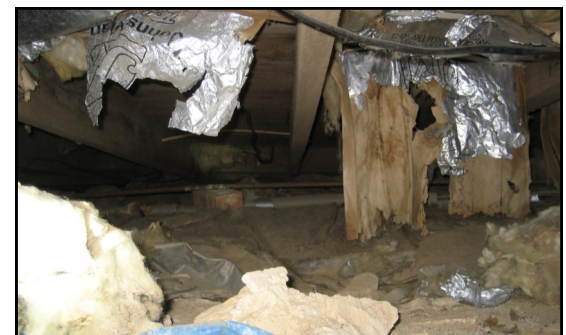
The crawlspace is very difficult to access. However client intends to rip up the floor to make repairs to the foundation. At this time, both a vapor barrier and insulation up to R19 are recommended.

Similarly, floor insulation is recommended but only if or when client's intention to fix and replace the floor occurs. The addition of a vapor barrier can also occur at this time.

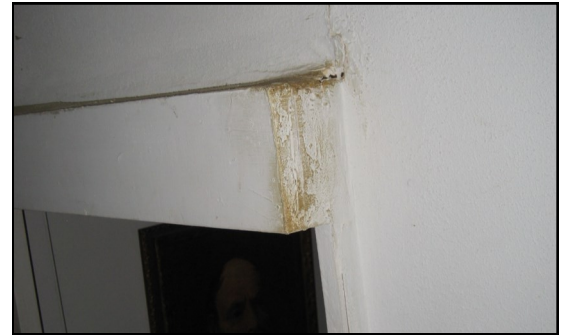
Air leakage was observed at any location in which there was a crack or space open to the frame of the house. Examples are pictured here, and in the next two photos. Not pictures, but significant was gaps in the master bedroom closet and behind the kitchen counters.

- 1.** Air sealing. The payback for air sealing is huge. Up to \$3000 can be spent on air sealing for a payback within 10 years, so long as the resulting air leakage rate achieved is 4000 CFM50 or better, which should be easily achievable. Areas to focus on are doors and windows; the floor; sealing any and all cracks to the house frame; and putting dampers on all exhaust fans. Also spray foaming the top plates in the attic could alleviate much of the leakage observed from the walls.
- 2.** Insulation should be added to all attic areas (over conditioned spaces), to between R38 and R49. Given the client's intention to create a cathedral ceiling in one part of the house, this then should be insulated to the highest level possible.

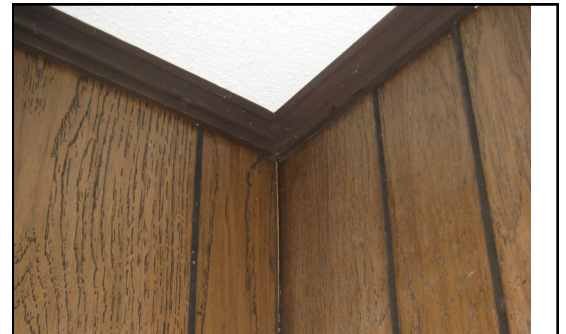
A gap in the kitchen paneling allows air to escape

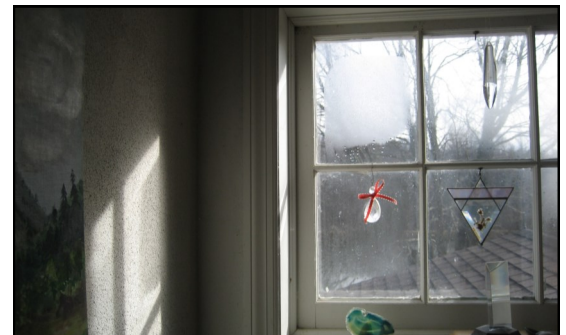
Window and door trim throughout the house are allowing significant air leakage. Pulling the trim off and filling with a two-part foam designed for doors and windows is recommended.

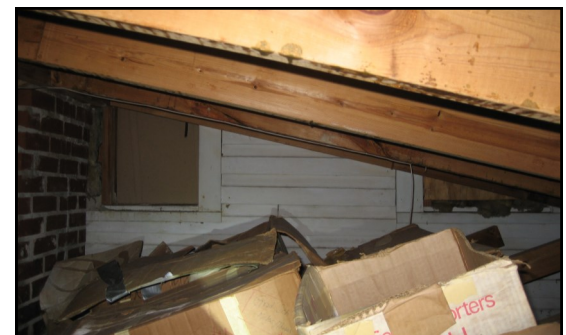
This old hatch, as viewed from above the garage, indicates a spot that must be insulated and sealed. Opposite this hatch is the master bedroom.

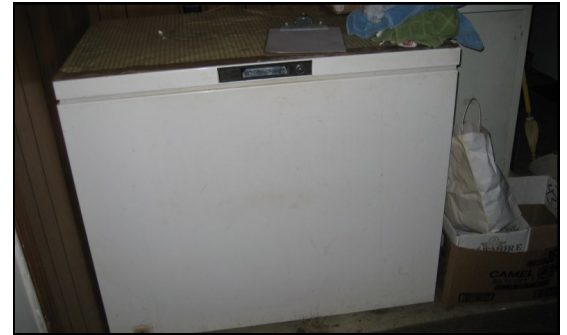
This Kenmore chest freezer is about 30 years old and is estimated to use about 1700 KWh/year. Comparatively, a new energy star freezer should use about 350 KWh/year.

This is similarly true for the fridge also, although it is only about 5 years old.

- 4.** Both the fridge and the chest freezer are recommended for replacement. The payback for each should be in the region of 6—7 years.
- 5.** There is no real improvement possible in replacing the dryer. However it is recommended to use it as little as possible. Clothes lines are slightly more labor intensive but use no energy. Try cleaning the lint from inside the machine and in the vent.

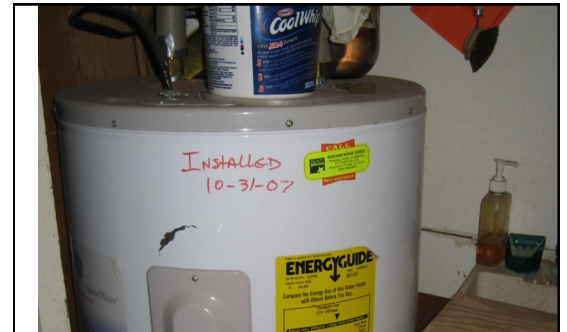
The water heater does not need to be replaced. However it should be wrapped with an insulating blanket, and all accessible pipes—both hot and cold, but hot in particular—should be insulated.

Additionally, the temperature can be reduced to 120' F for added savings, with no loss of comfort.

- 6.** Similarly, replacing the water heater is not recommended at this time. However, wrapping it in at least an R8 insulating jacket and also wrapping the exposed water lines should pay back the cost and effort within less than a year. Reducing the temperature of the storage tank to 120' will also add to savings. One further way to save on water heater costs is to install low-flow showerheads and faucet aerators. Also, the water heater should be drained at least once a year.

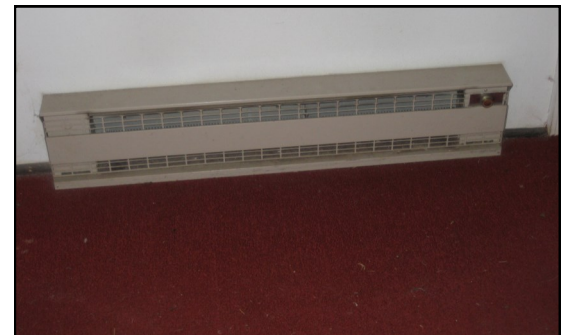
On the chance that baseboard heaters are not fully turning off, they can most easily be disabled at the breaker box during the non-heating seasons.
